**THE POTENTIAL OF HIGH COPPER ALLOYS AS
ALTERNATIVE MATERIALS FOR POST-AND-CORE
APPLICATION**

**A THESIS SUBMITTED IN PARTIAL FULFILLMENT
OF THE REQUIREMENTS FOR
THE DEGREE OF MASTER OF SCIENCE (PROSTHODONTICS)
FACULTY OF GRADUATE STUDIES
MAHIDOL UNIVERSITY**

2004

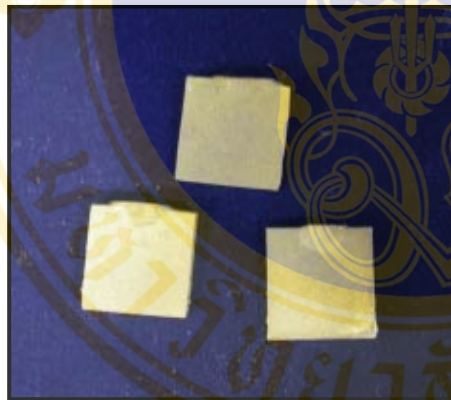
Figure 3-3 specimens before polishing Figure 3-4 specimen after polishing

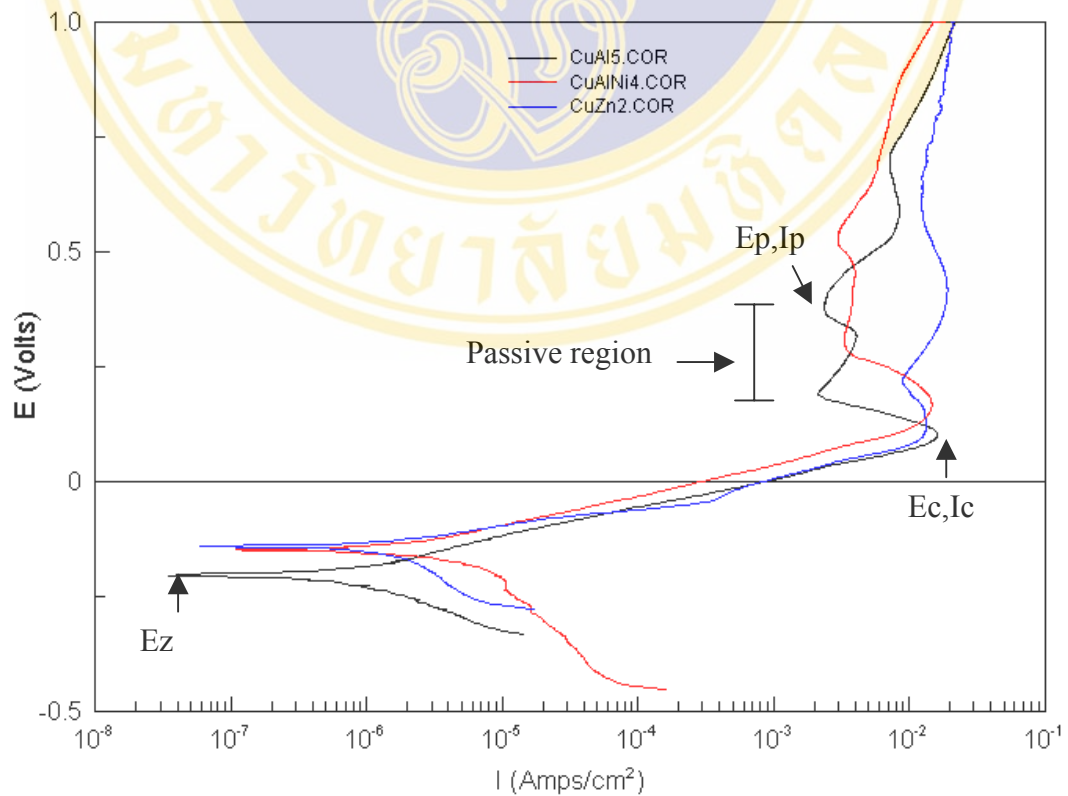
Figure4-1 Potentiodynamic polarization curves for three copper alloys in 37°C de-aerated 0.9% NaCl solution.

From Figure 4-1, the current densities were on the order of 10^{-3} to 10^{-2} A/cm², a very high dissolution density, unlike the usual current densities in the passive state, 10^{-8} to 10^{-6} A/cm², three to four orders of magnitude lower, for the truly passivating alloys. There was selective dissolution of these alloys. Thus the potential region above E_c shown a complex behavior including selective dissolution of Zn and Al, formation of oxides and chlorides, and the current density limitation resulting from accumulation of corrosion products.

The potentiodynamic curve of CuZn had no passive region. It implied that this alloy has lowest corrosion resistance between these three alloys. While the curve of CuAl had shorter passive region than that of CuAlNi and above E_c , its curve looked like wave because the oxide compounds were oxidized and its protective film changed structure and composition. So, CuAl had lower corrosion resistance than CuAlNi.

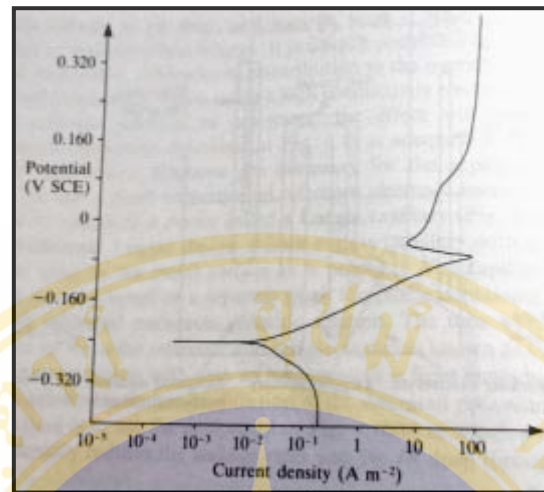
Figure 5-1 Potentiodynamic scan for copper in 3.5% NaCl solution

Additionally, formation of very thin protective film may be due to characters of these alloys and using 0.9% NaCl as test media. Comparing to potentiodynamic curve of copper in 3.5% NaCl (48), they look like in the same pattern (Figure 5-1). The corrosion reaction of copper, especially in a solution containing chloride ions, were quite complicated, but the reactions might briefly be described as the formation of copper (I) (cuprous) and copper (II) (cupric) oxides, together with insoluble hydrated chlorides. Mayer and Nally (49) indicated that 0.9% saline solution was considered to be more aggressive than saliva and its artificial substitutes, because the chloride which was six time higher. Moreover, it lacks of some component which might show a corrosion inhibited action and a buffer capacity such as phosphate. Marek and Topfl (50) suggested that 1% NaCl was unsuitable for measurement other than the screening test for generalized corrosion.
